**XYZ Corp.**

**December 7, 2015**

**Full Plant Survey**

### Machinery Vibration Analysis Report

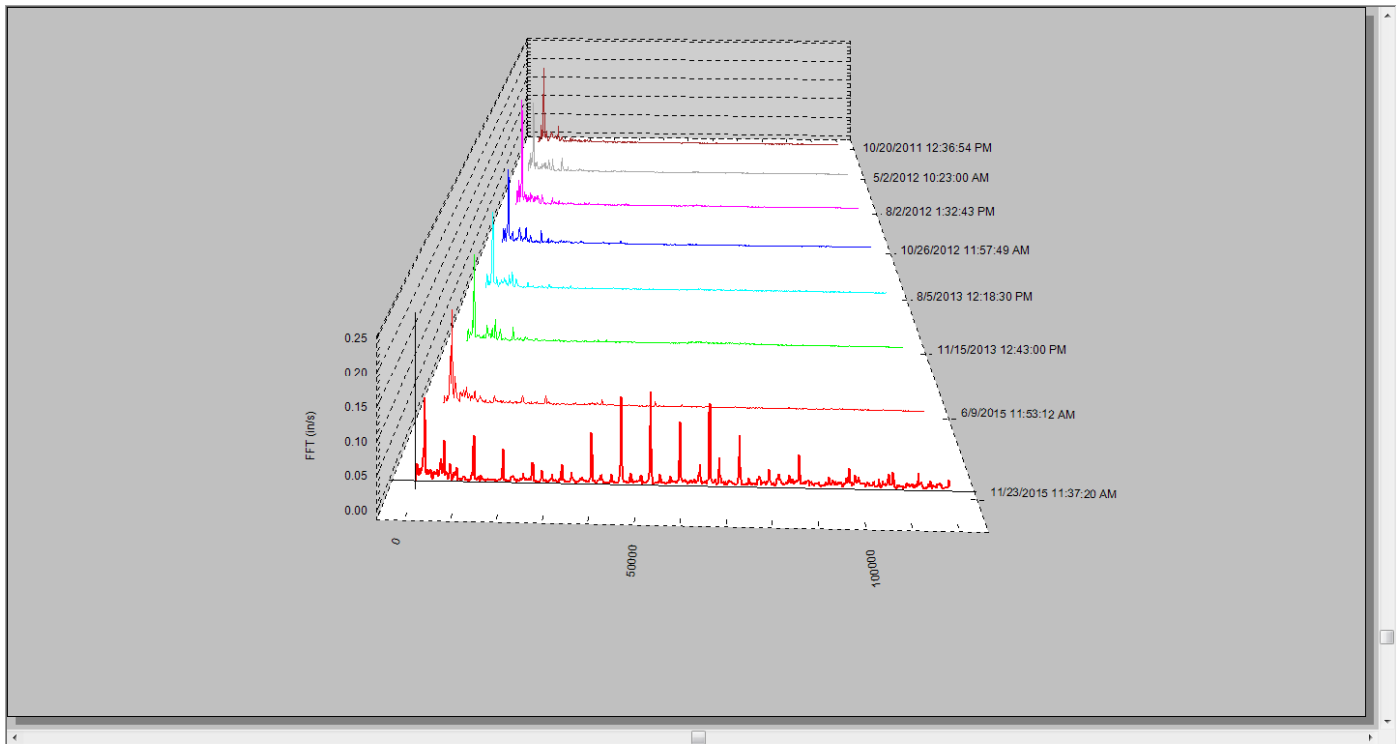
#1 Baghouse Fan	<p><b>6-9-15</b> Slight change in characteristic noted in the acceleration enveloping data of the drive end fan bearing; possible early stage wear appears to be developing.</p> <p><b>8-12-15</b> Unit not running at time of survey.</p> <p><b>11-23-15</b> Sharp increase in HFD level as well as acceleration overall level in drive end fan bearing. Possible bearing wear is noted in spectral data at high amplitudes. Suspect this bearing is severely worn. This was reported prior to leaving plant.</p>	<b>High</b>
-----------------	--	-------------

RECOMMENDED ACTION: Replace fan bearings promptly.
